Re: MVCA Technical Review Memorandum (dated July 8, 2022, Revised August 24, 2022)
Slope Stability Engineering Review

Hilan Village Residential Subdivision Application,
38 Carss Street, Almonte Ontario
File Number 09-T-22003

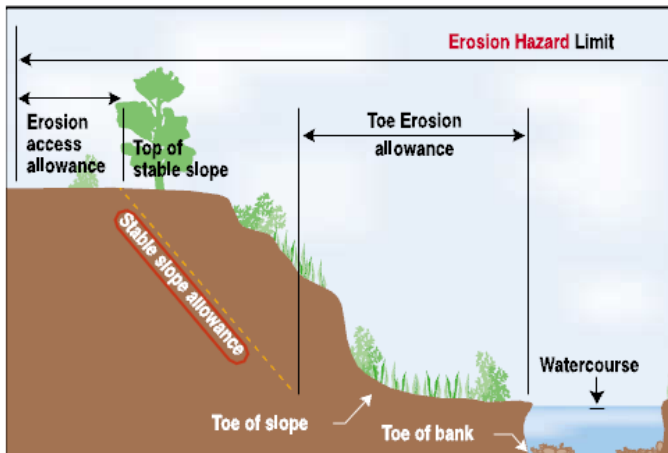
Figure 115 b - Stable Slope Allowance
(toe of valley slope $\leq 15\text{m}$ from watercourse)

Figure 115b – Stable Slope Allowance was copied from the MNRF guidelines. This figure clearly illustrates that the toe erosion allowance is measured from the toe of the slope where the toe of the slope is less than 15 metres from the toe of the bank. As discussed on page 10 and 11 of the report, the application of 6 metres of toe erosion allowance at the toe of the slope will not change the overall stability of the slope or cause the stable slope allowance to immerge past the top of the slope.

The wording and illustrations in the Technical Guide state that the erosion access allowance be added to the stable slope allowance after the stable slope allowance is added to the toe erosion allowance. The Figures 95b and 115b clearly illustrate that toe erosion allowance begins at the toe of the bank or at the watercourse. Figures 115a and 115b clearly illustrate that the stable slope allowance is applied either beginning at the toe of the slope or following the toe erosion allowance.

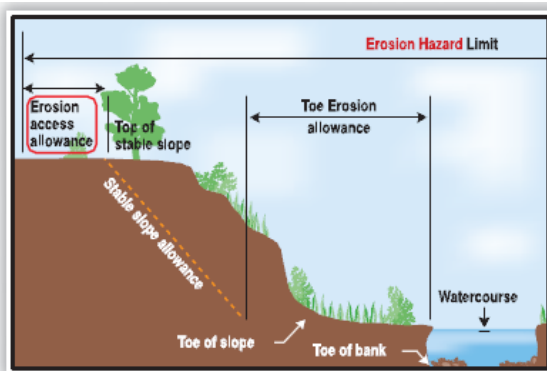
Figure 123 - Erosion Access Allowance:

*In Figure 123, the erosion access allowance is being added to the stable slope allowance designated by a line marking the top of the stable slope. **This line marks the top of stable slope not the top of slope.** The erosion access allowance is not being added beginning at the top of the slope. In Figure 124, the excavator is operating within the erosion access allowance at some point below the top of slope as the slope clearly extends upward beyond the excavator.*

The application of the erosion access allowance for confined systems is illustrated in the figures copied below.
